DELET-TR-80-2

**AUTOCLAVE TESTING OF PLASTIC ENCAPSULATED 400I CMOS  
INTEGRATED CIRCUITS**

**Richard Holevinski  
ELECTRONICS TECHNOLOGY & DEVICES LABORATORY**

**January 1980**

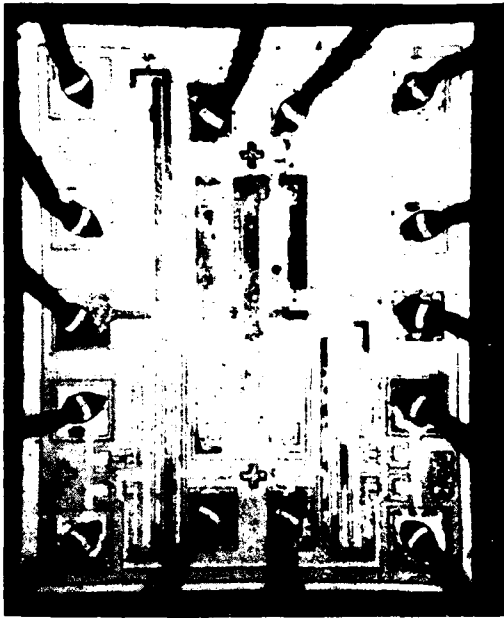
Figure 4. Micrographs of Type 4001 die from vendors C and D.

In Figures 2 through 5, the micrographs show various degrees of aluminum corrosion on some of the 4001-type circuits from the autoclave testing. These micrographs also show the wide range of vendor design layouts used for the circuit dice. Each vendor used his own layout and even these varied from older to newer date coded circuits. Only vendor B used the same layout for both date-coded circuits evaluated.

Type C1 biased for 96 hours

Type C2 biased for 144 hours

Type D1 biased for 120 hours

Type D2 unbiased for 1008 hours

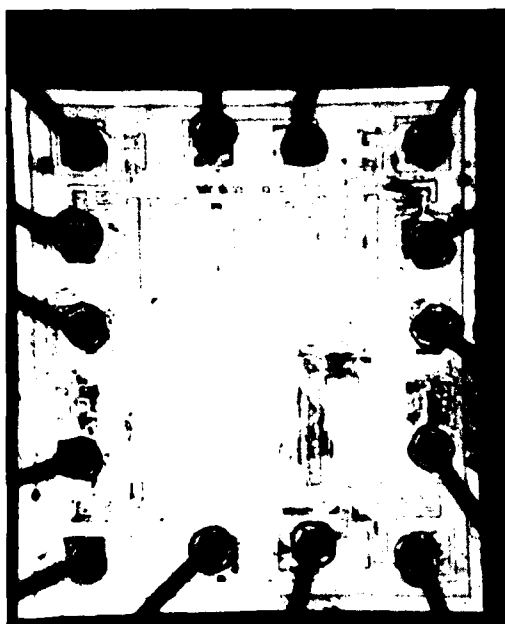
Figure 5. Micrographs of Type 4001 die from vendors E and F.

Type E1 biased for 144 hours

Type E2 biased for 96 hours

Type F1 biased for 288 hours

Type F2 unbiased for 2792 hours

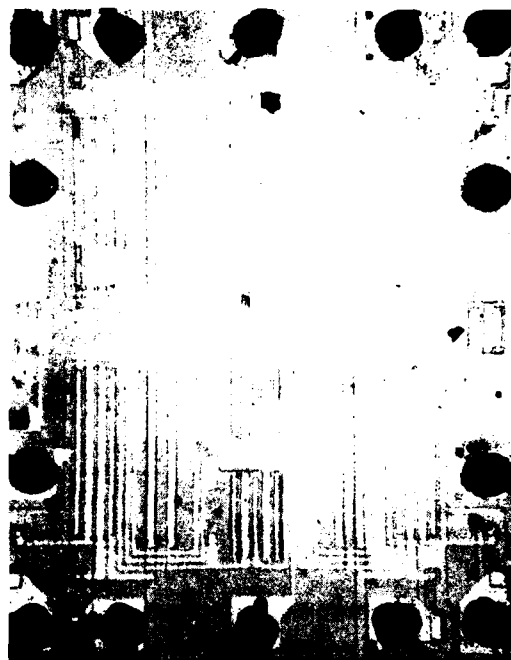
Figure 6. Micrographs of Type 4001 die from vendors G, H, I and J

Type G biased 96 hours

Type H biased 216 hours

Type I unbiased 168 hours

Type J unbiased 408 hours

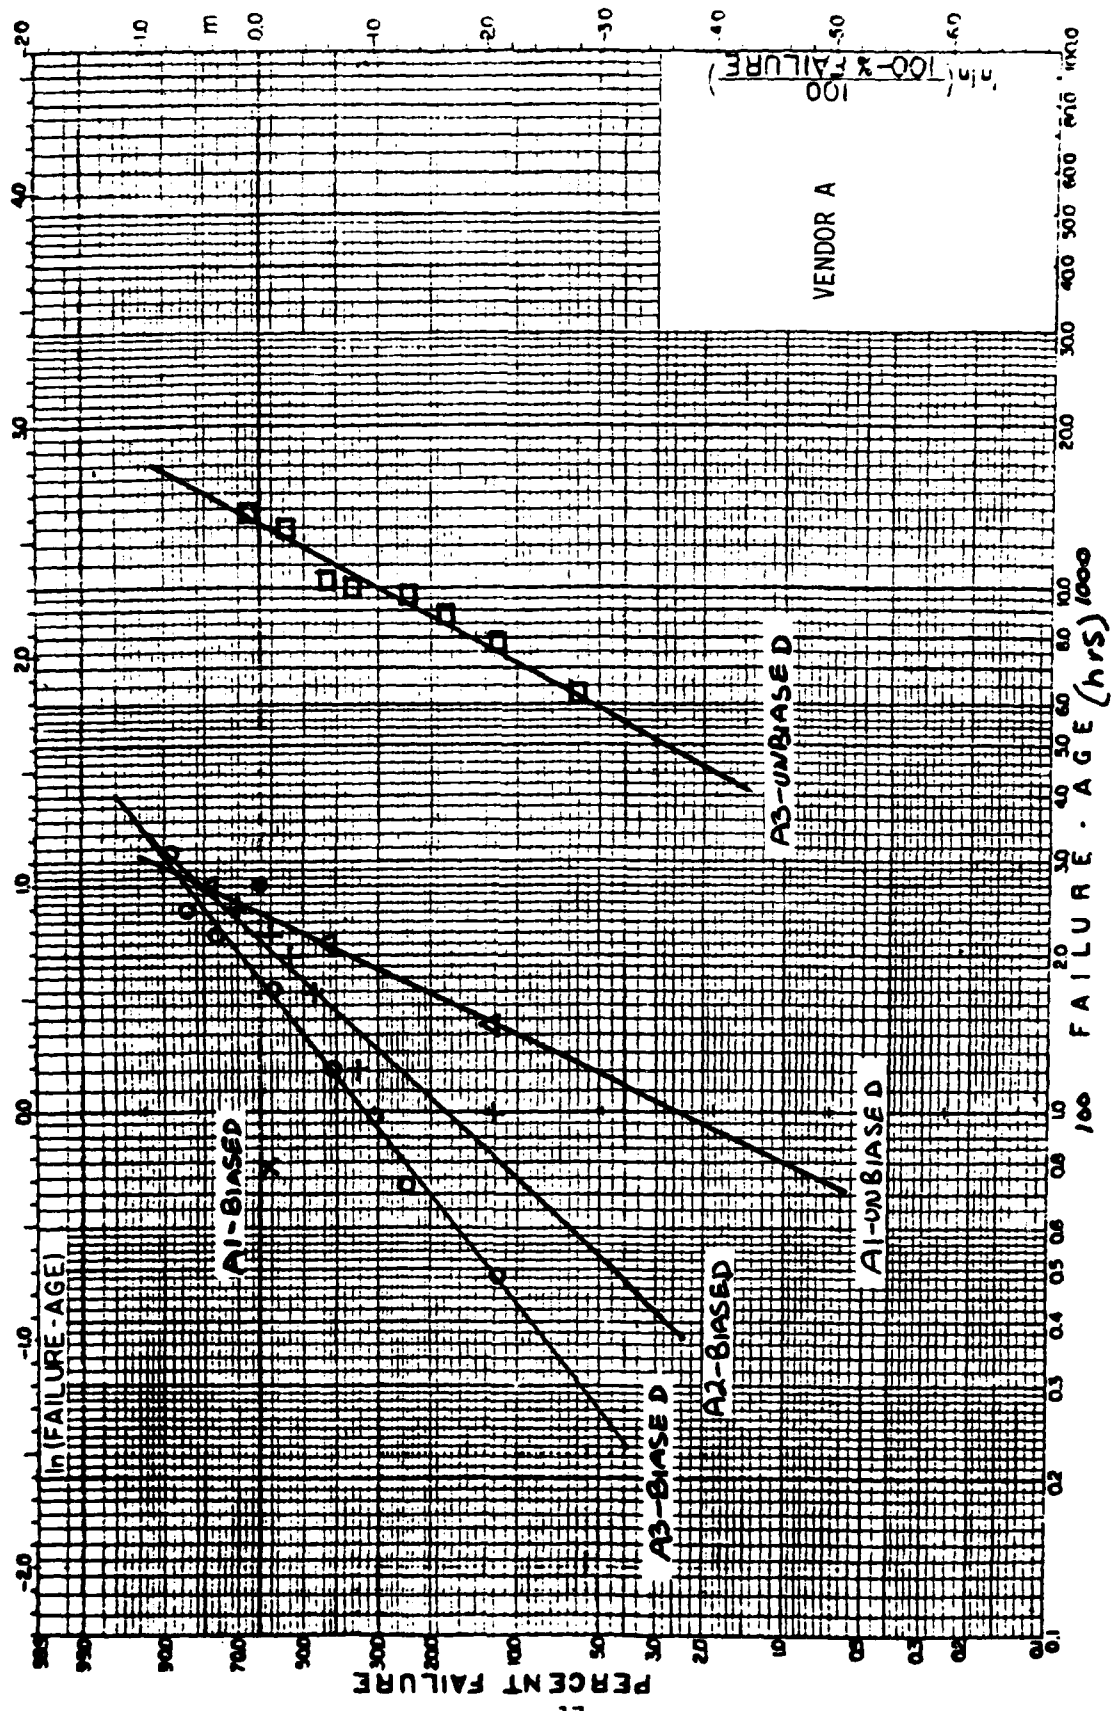
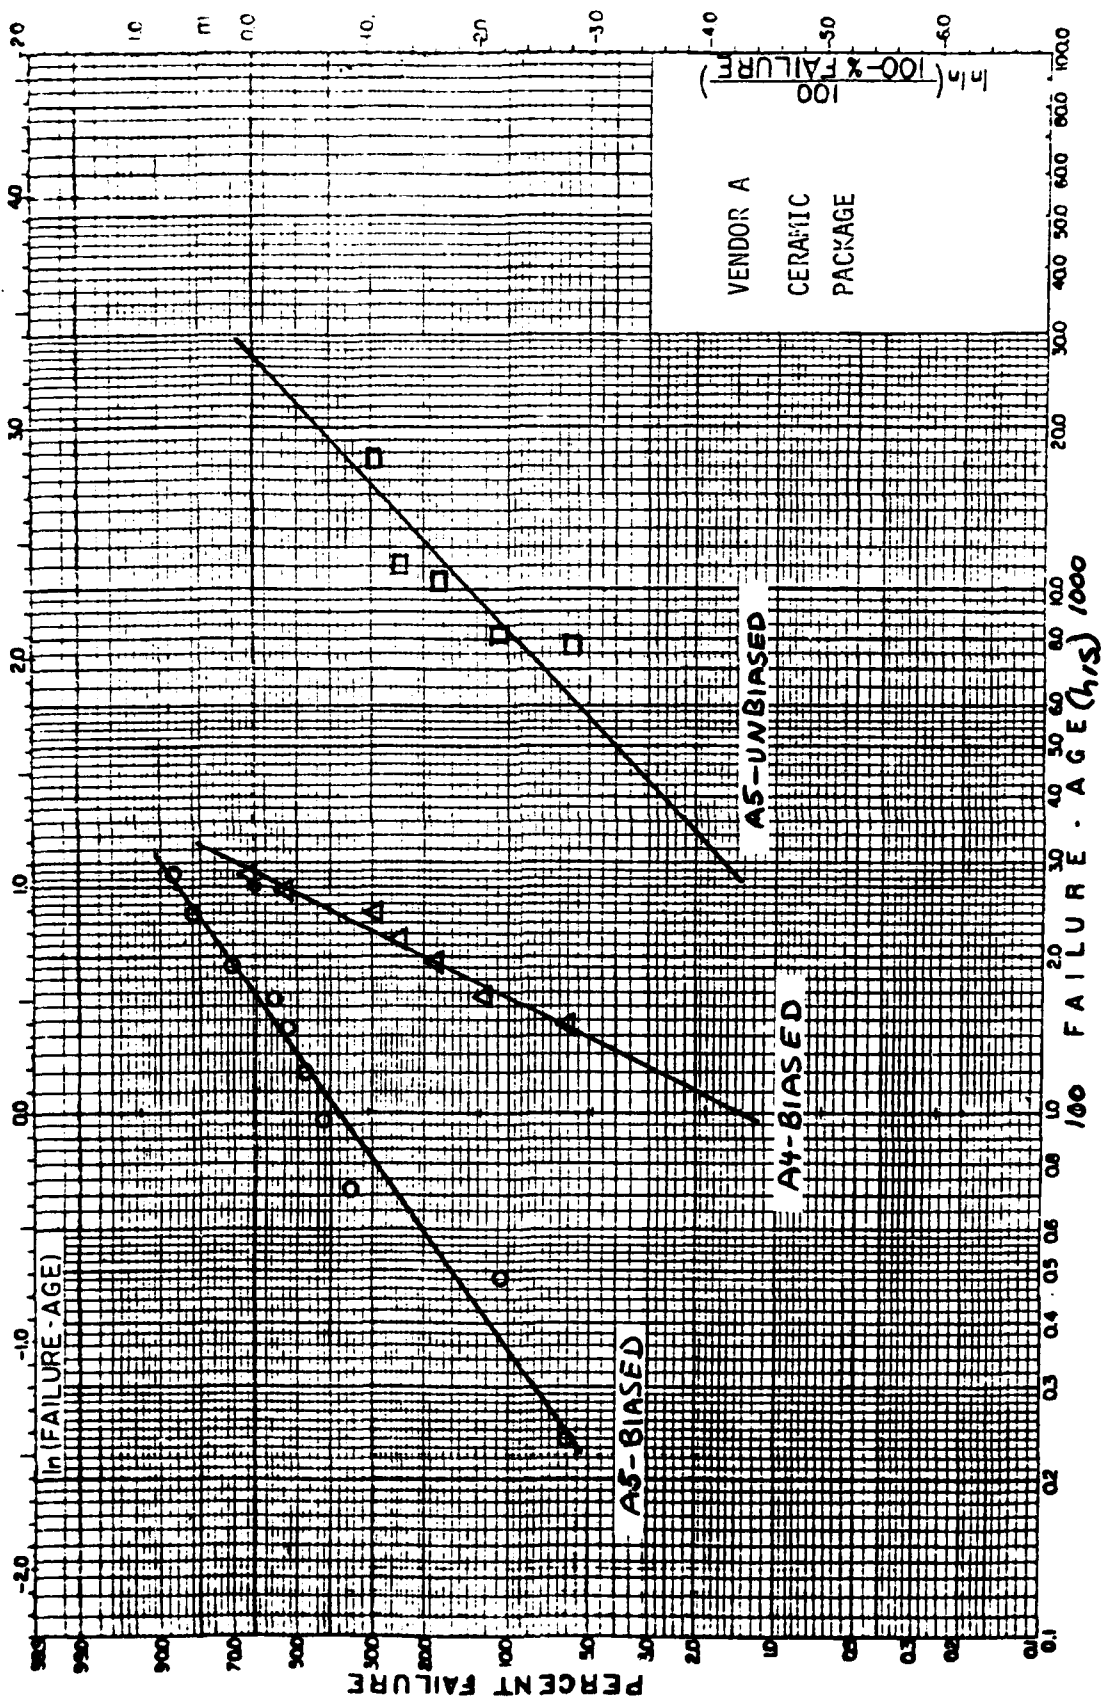
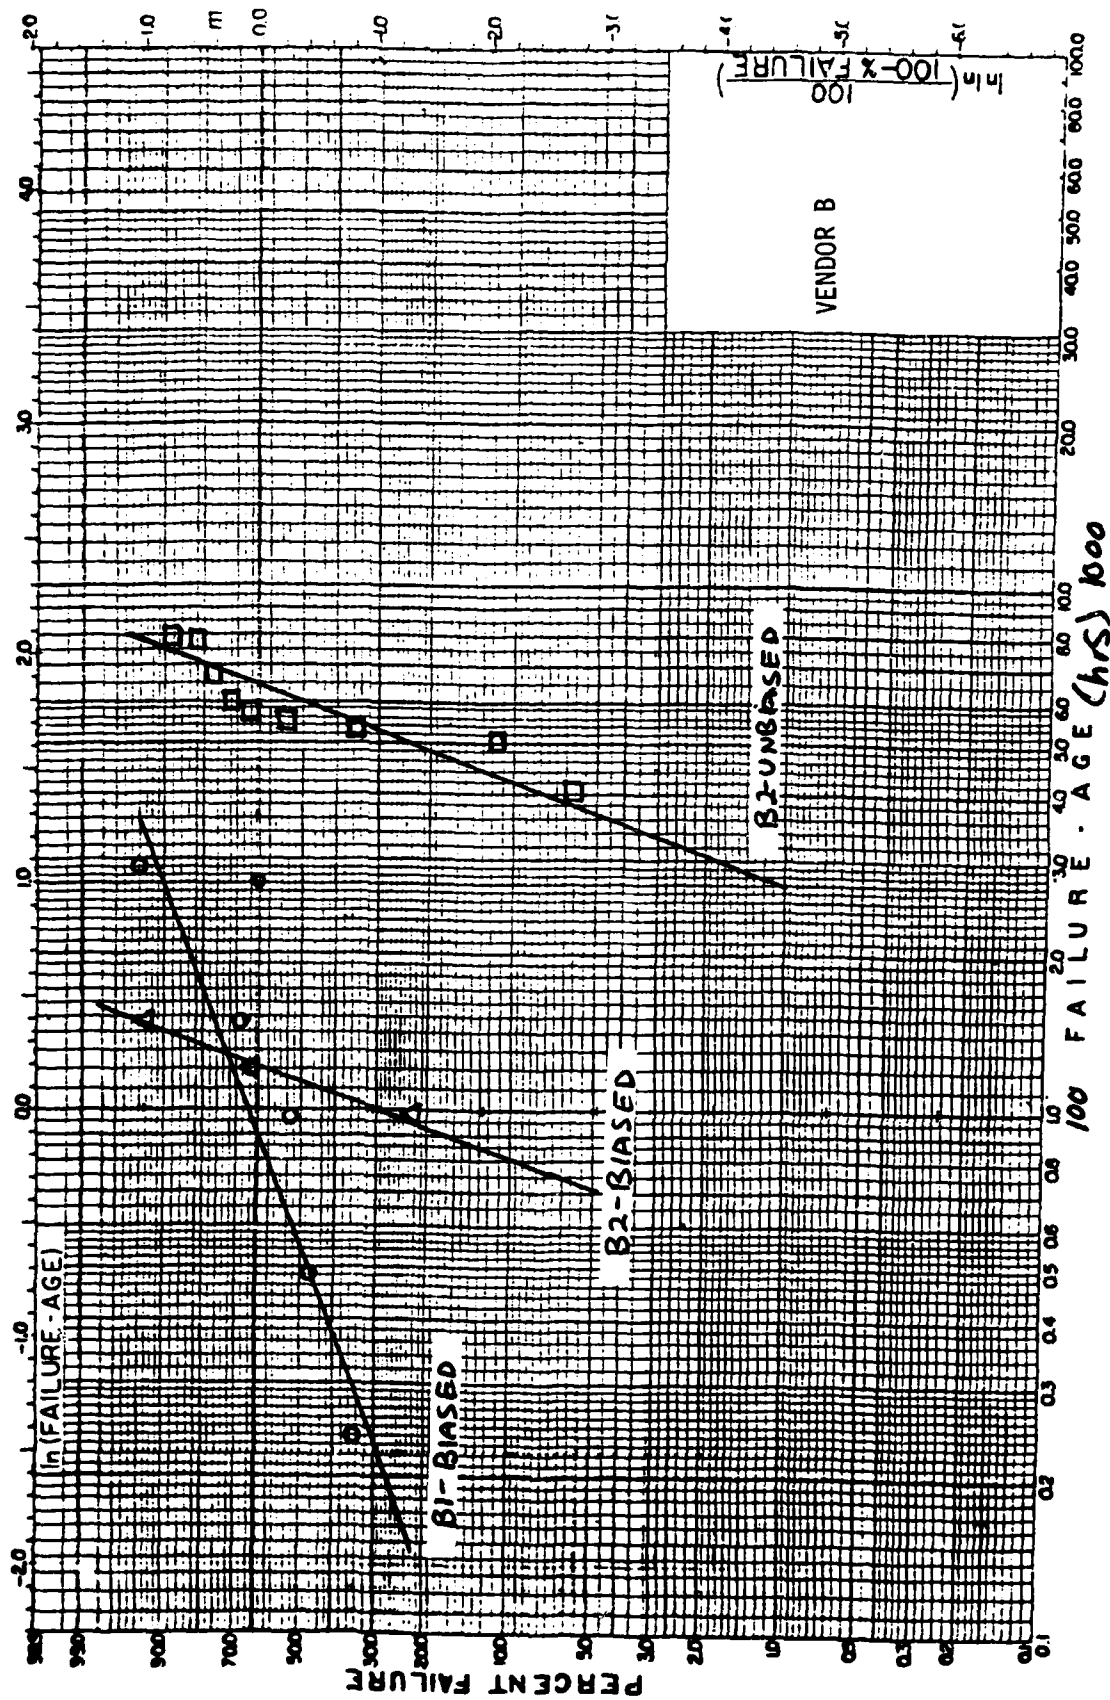
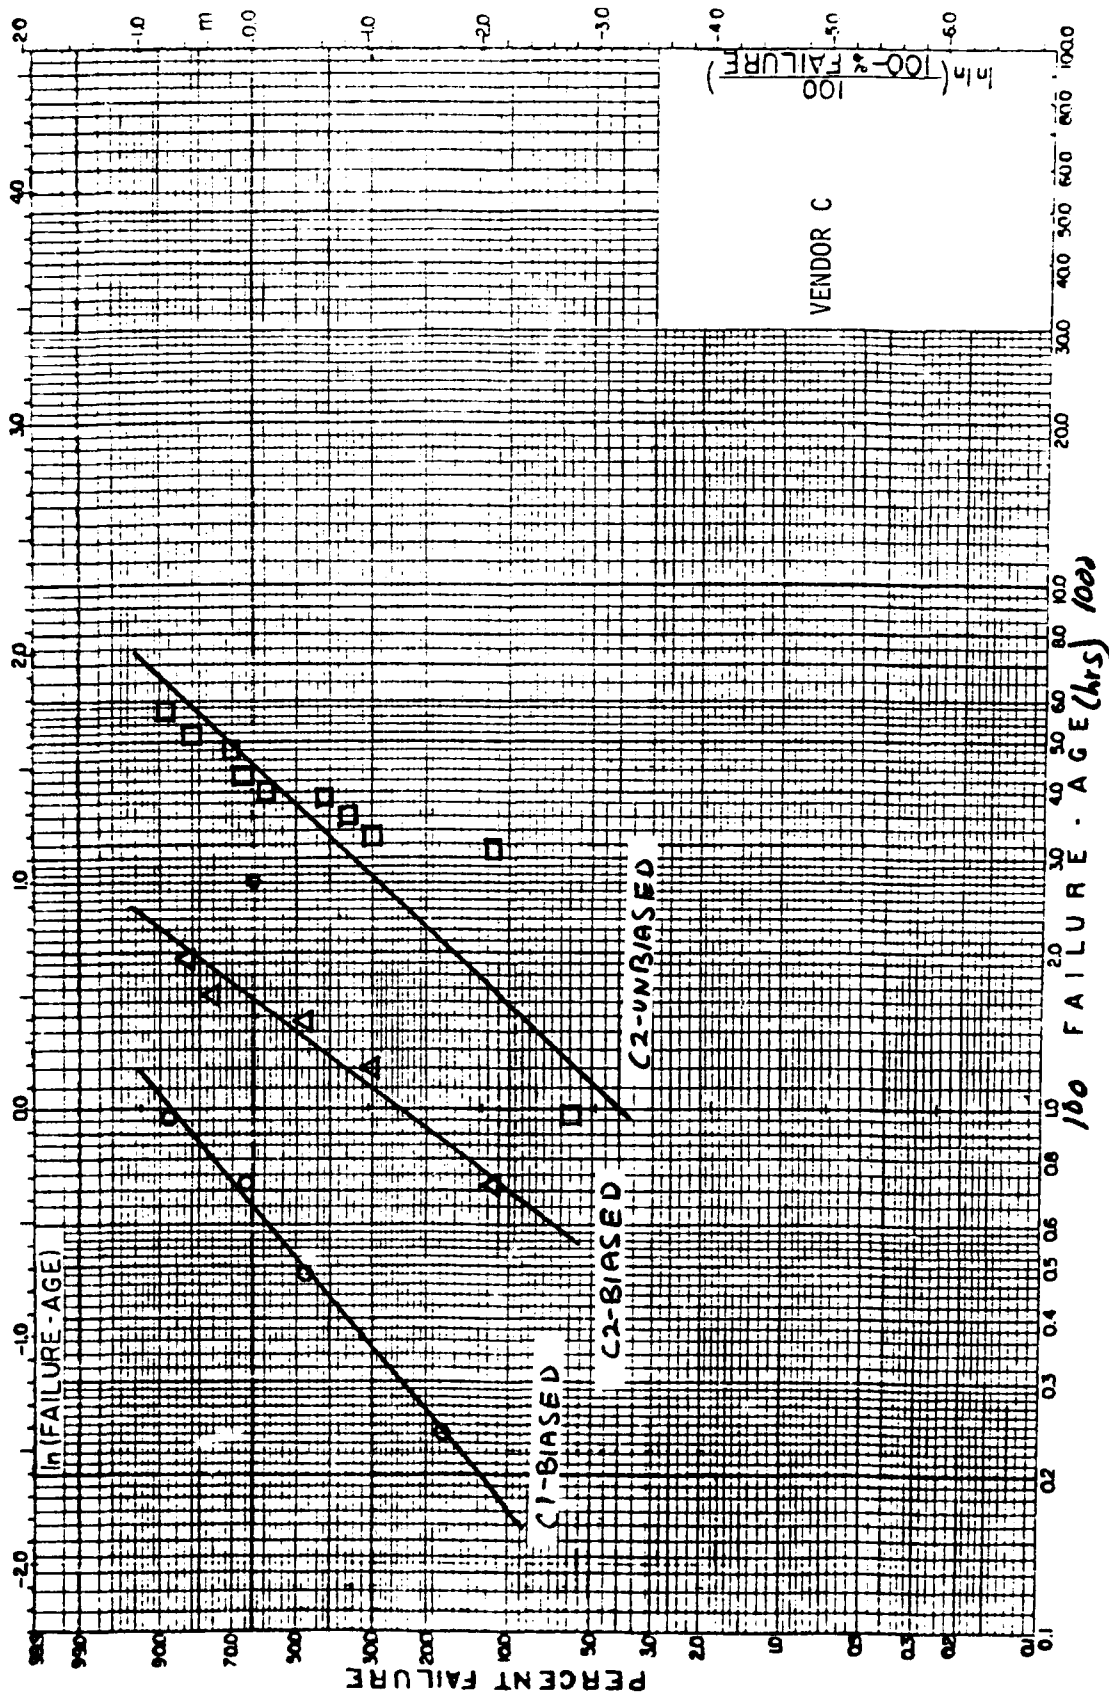
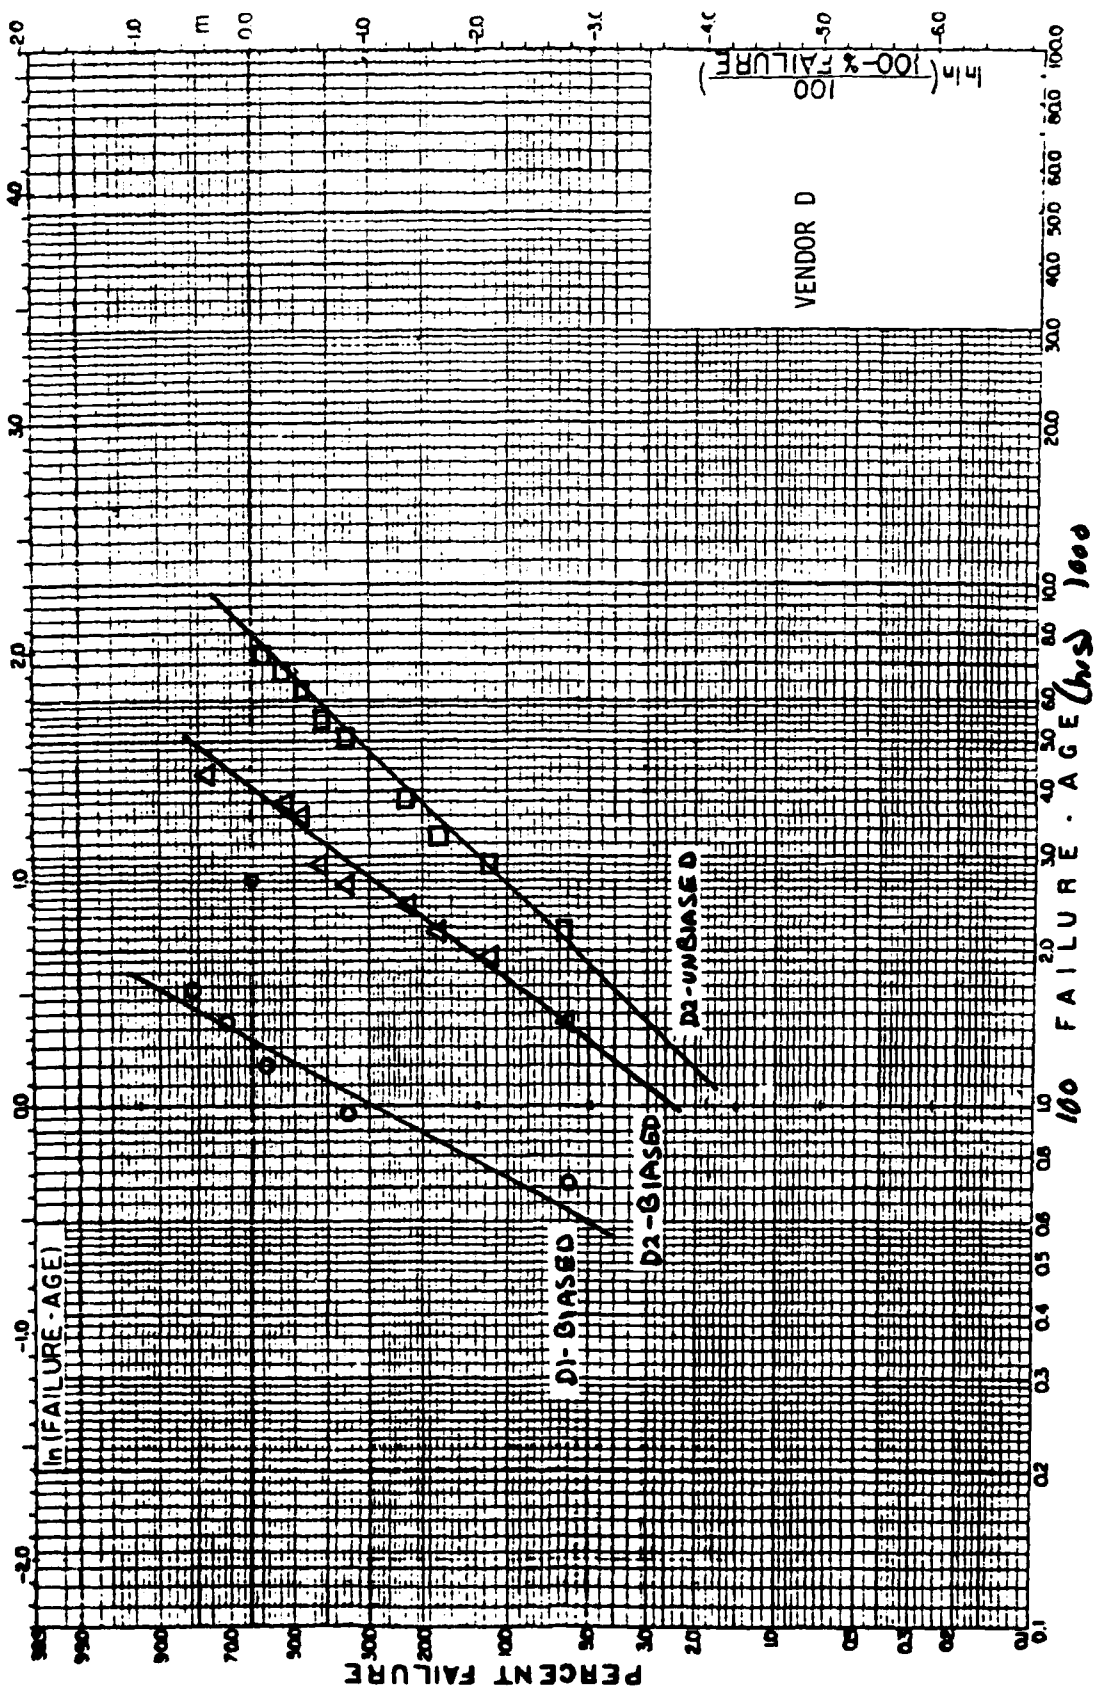
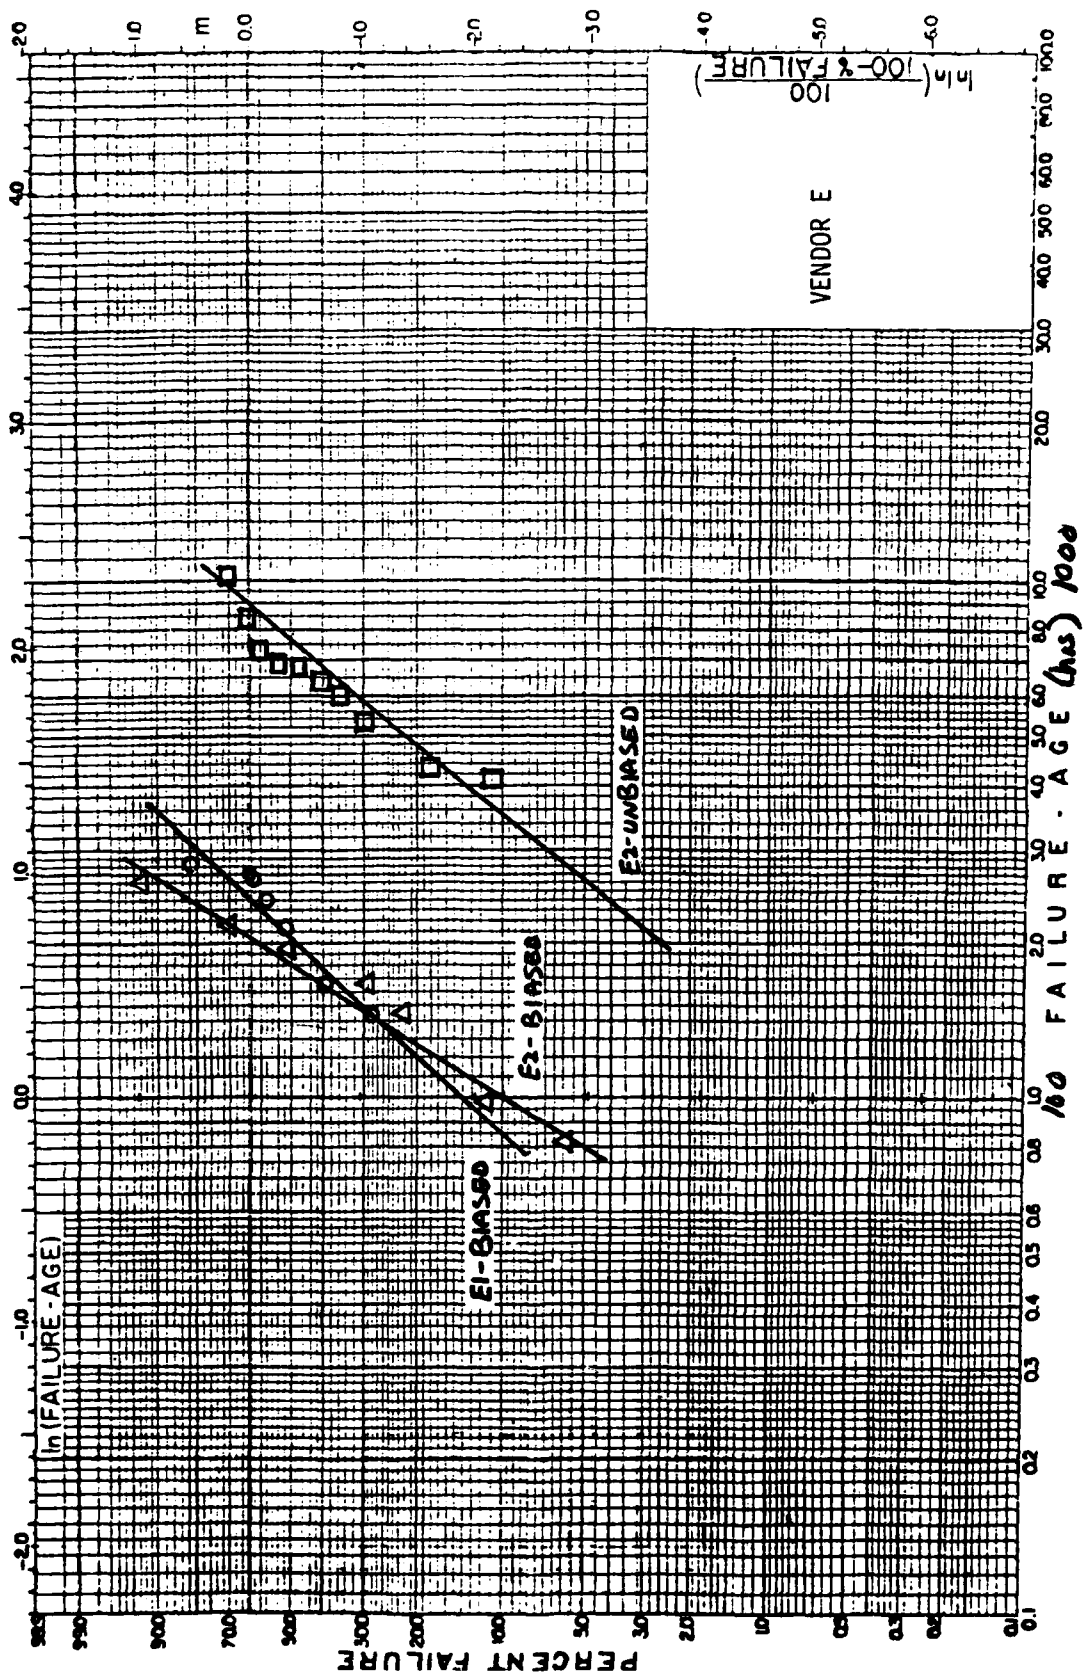
### WEIBULL PROBABILITY DISTRIBUTIONS

Each vendor's test data was plotted on Weibull probability graphs and failure distributions were determined for each group. The Weibull graph is a plot of cumulative percent failure versus total test time. Appendix A shows a Weibull probability graph for each vendor group. From the Weibull graphs, the median life in hours, shape parameter or slope of the curve and the correlation coefficient of each curve was determined. In Table 3, this information is tabulated for the vendor groups which were biased at 5 volts in the autoclave. Table 4 contains the tabulated information for the unbiased groups. The consistently high correlation coefficients support the validity of applying the Weibull distribution to the test data.

The shape parameter, which is the slope of the Weibull curve, is a useful parameter because it gives a direct indication of the failure distribution. Shape parameters of  $<1.0$  indicate dominant early-failures by parts having a high proportion of weak or marginal devices. Shape parameters of  $>1.0$  indicate a wearout behavior by parts that fail within a short time span. The importance of the shape parameter is reflected by the results of vendor B. This vendor was the only one to use the same style die for both the older (B1) and newer (B2) date-coded parts. The data distributions for the biased autoclave test shows that the shape parameter changed from 0.7 to 5.5 with a corresponding increase in median life from 55 to 110 hours. This substantial effect on the shape parameter was promoted by a simple change of plastic encapsulant from silicone to an

In general, for the biased autoclave test, each vendors' newer date coded PEDs had longer median life times than older date coded parts by factors of 2 to 3. The only exception to this observation was vendor E whose PEDs had relatively similar median life times, regardless of date code. These life times were longer than most from the other vendors.

For each vendor, the unbiased autoclave tested PEDs had longer median life times than the corresponding groups biased in the autoclave by factors of 1.9 to greater than 8.5. The ranges of median lifetimes between vendors in the autoclave tests precluded the generation of an acceleration factor between biased and unbiased autoclave tests for the PEDs. For example, vendor D's circuits had the longest median life (360 hours) with bias and only average median life (670 hours) with no bias, giving an acceleration factor of 1.9. Vendor A3, on the other hand, had circuits with the longest median life (1200 hours) with no bias and only average median life (140 hours) with bias, giving an acceleration factor of 8.6.
